TEST FILLS FOR ROCK-FILL DAMS

MISCELLANEOUS PAPER S-73-7

Conducted by U. S. Army Engineer Waterways Experiment Station
Soils and Pavements Laboratory
Vicksburg, Mississippi

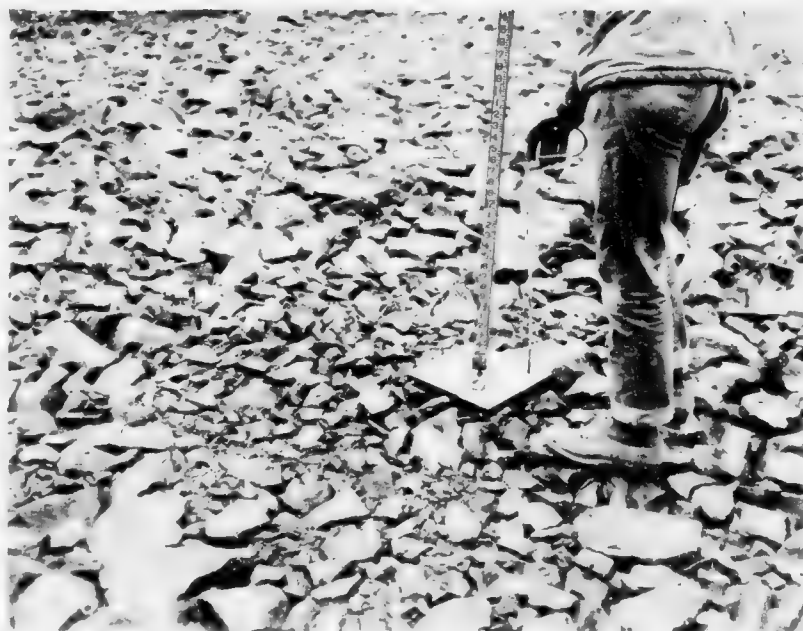
Fig. 27. Apparatus for taking level readings, Cougar test fill
